# Blue outline, white outline...

## Part 2

# Colours of the Czechoslovak Air Force S-199

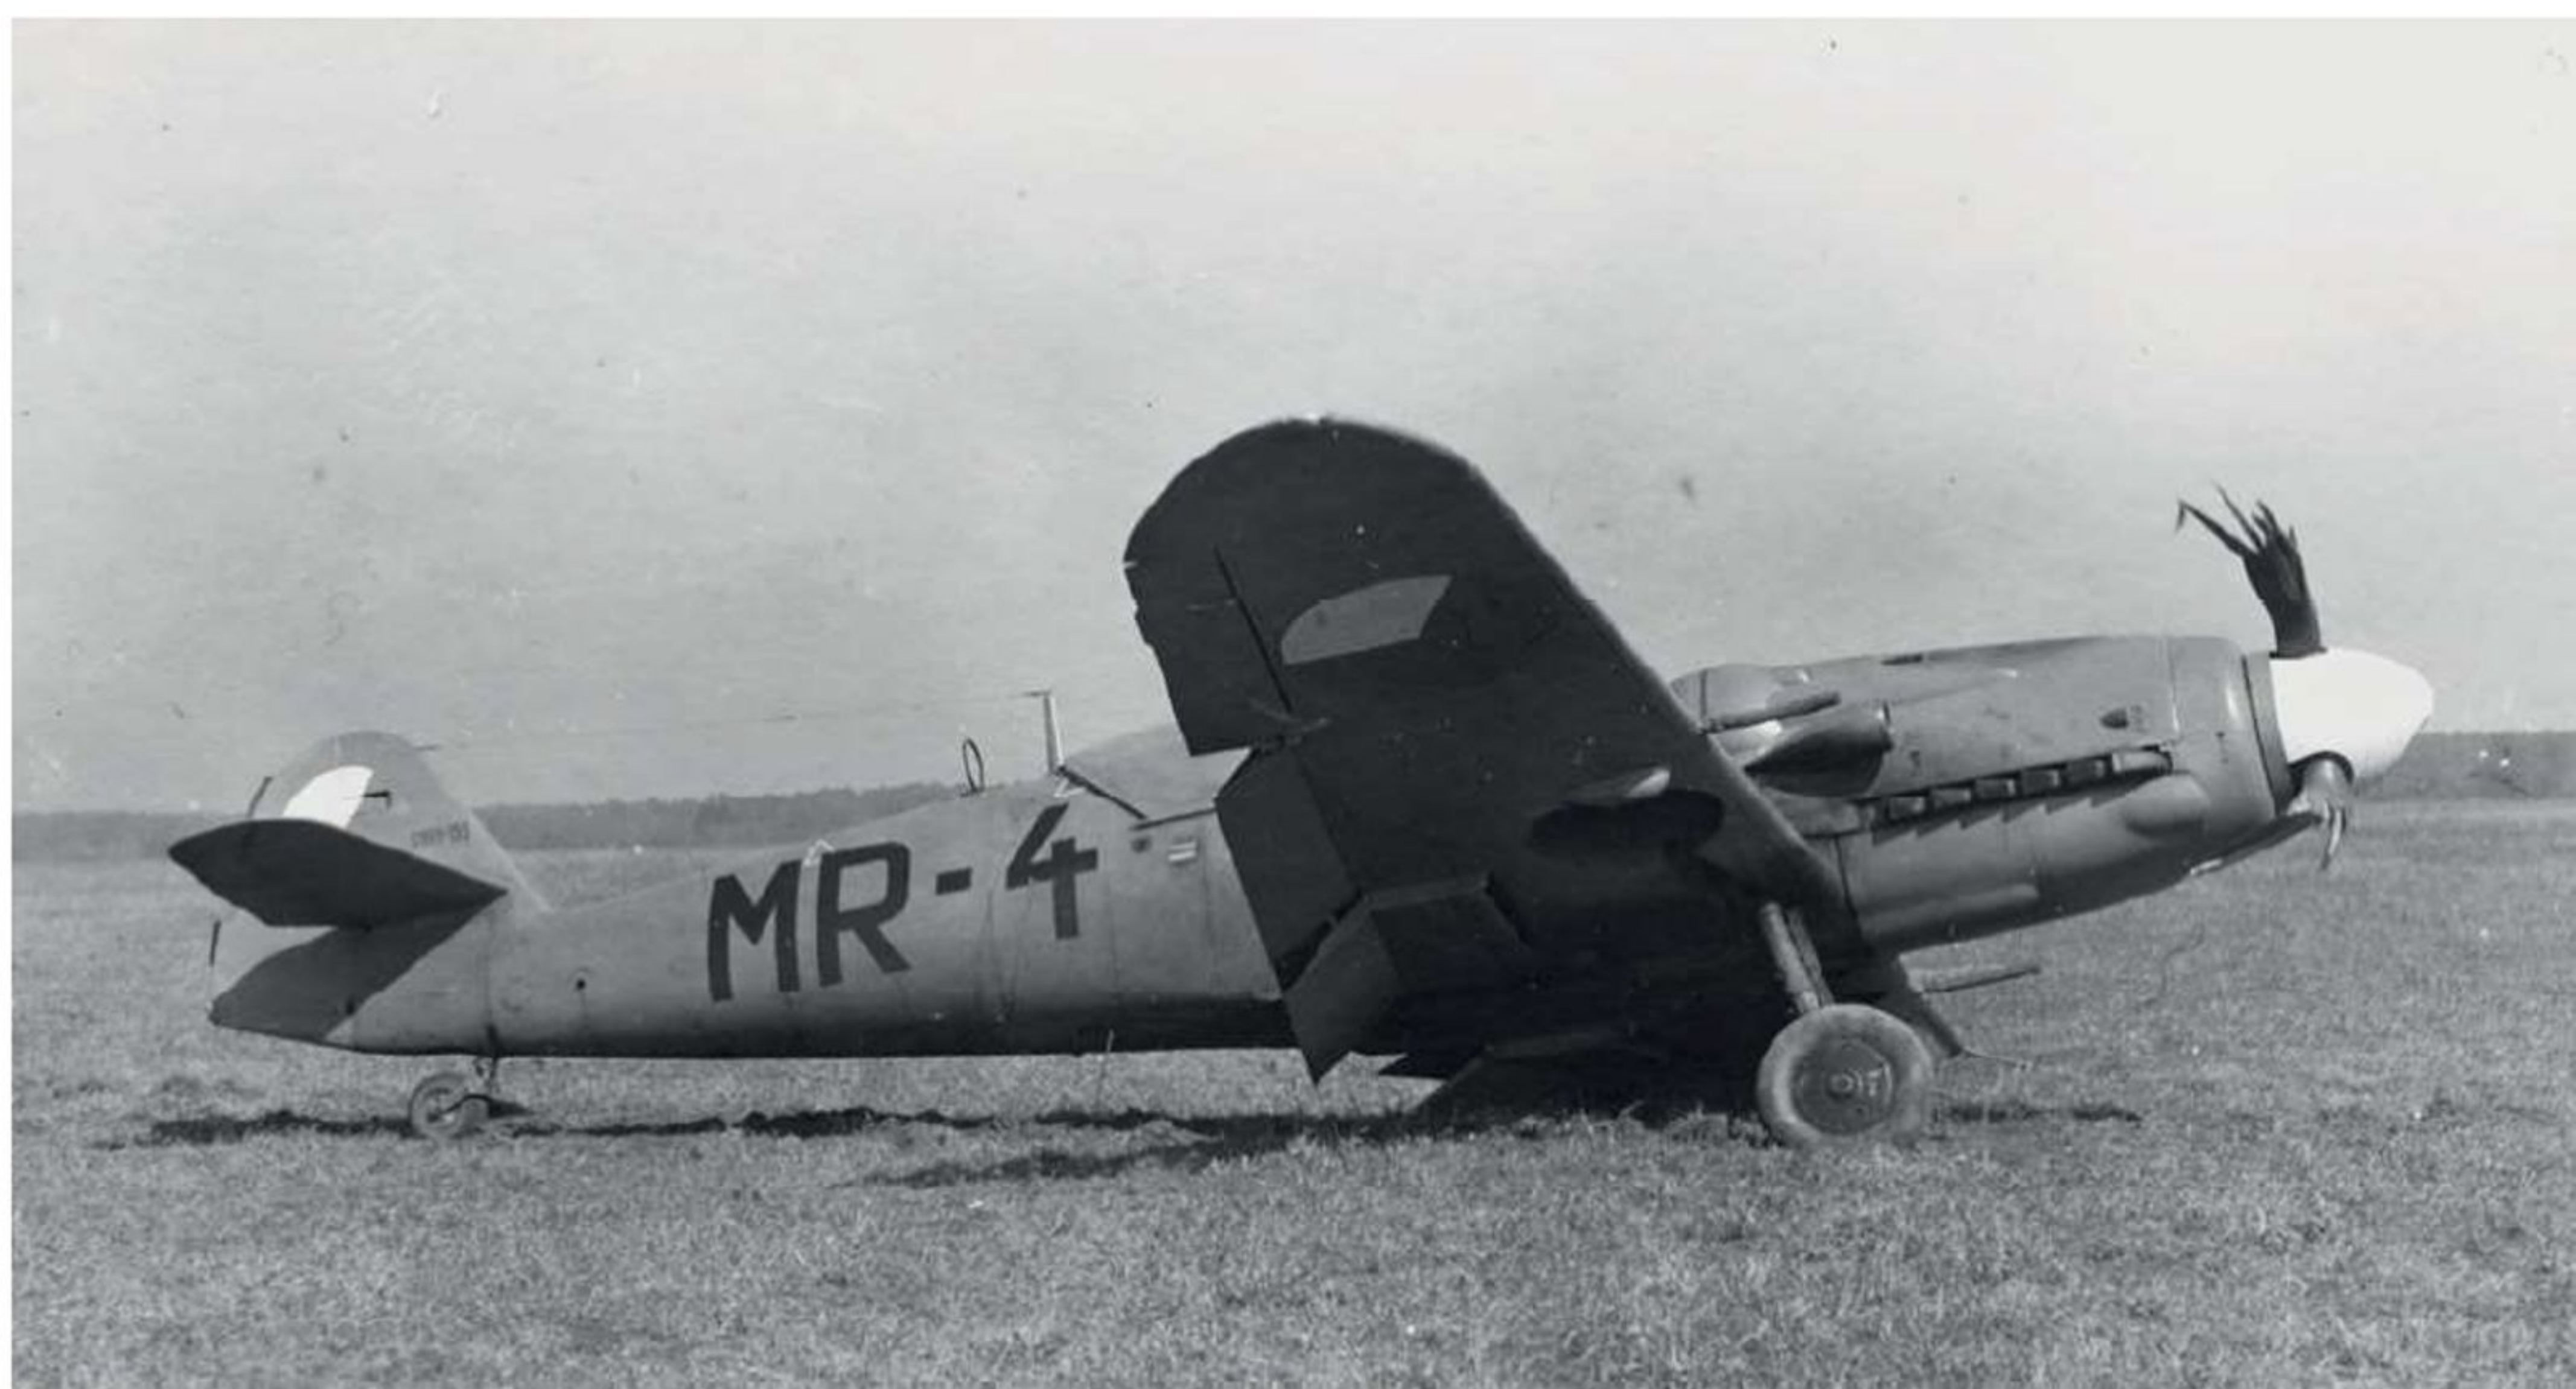
*Avia S-299.155, "black" MR-4 from the 2nd flight of the 8th Fighter Squadron in Brno-Cernovice camouflaged in the light grey-green color. This crash occurred on March 24, 1949 while the aircraft was piloted by Lt. Frantisek Krist. The image of the lower wing half nicely shows the location of the national insignia with the thin blue outline, further the "baby bulge" of the ammunition belt links collector of the model 17/7.9N wing machine gun and the starboard liquid cooler with deployed discharge flap. The gun barrels are again protected by the linen covers.*

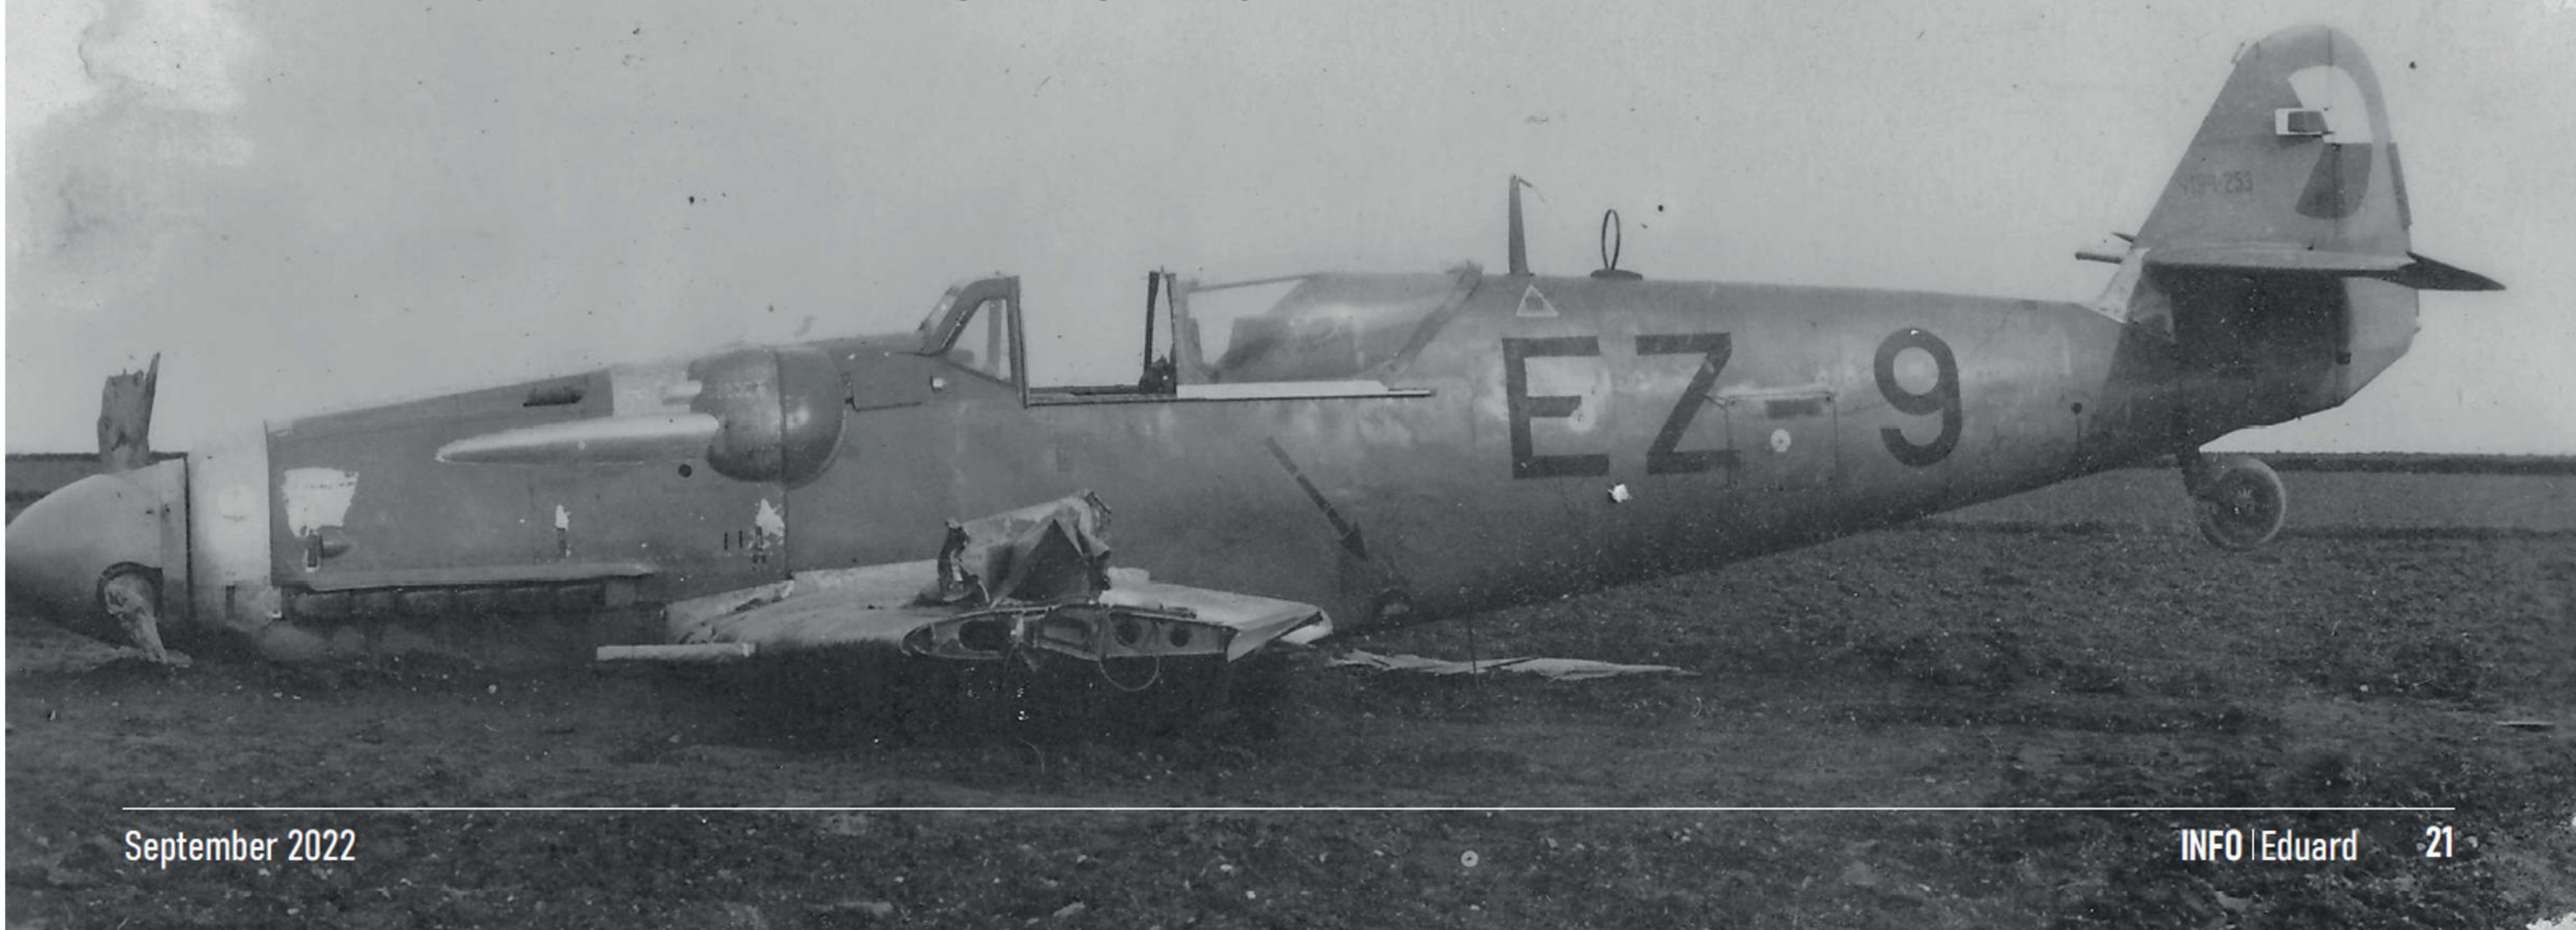
*Avia S-199.253, "black" EZ-9 from the 3rd flight of the 5th Fighter Squadron in Plana at Ceske Budejovice as mentioned in this article, demonstrating the attractive camouflage. This emergency landing resulting in the damaged wing and the bottom of the fuselage was performed by WO Jiljí Horak. Notice the unpainted metal skin panels on the nose, cowling and replacement fuselage-vertical tail fairing. The aircraft also features the very thin outline on the vertical tail surfaces national insignia. Of interest are also the protective fabric covers on the fuselage and wing machine guns.*

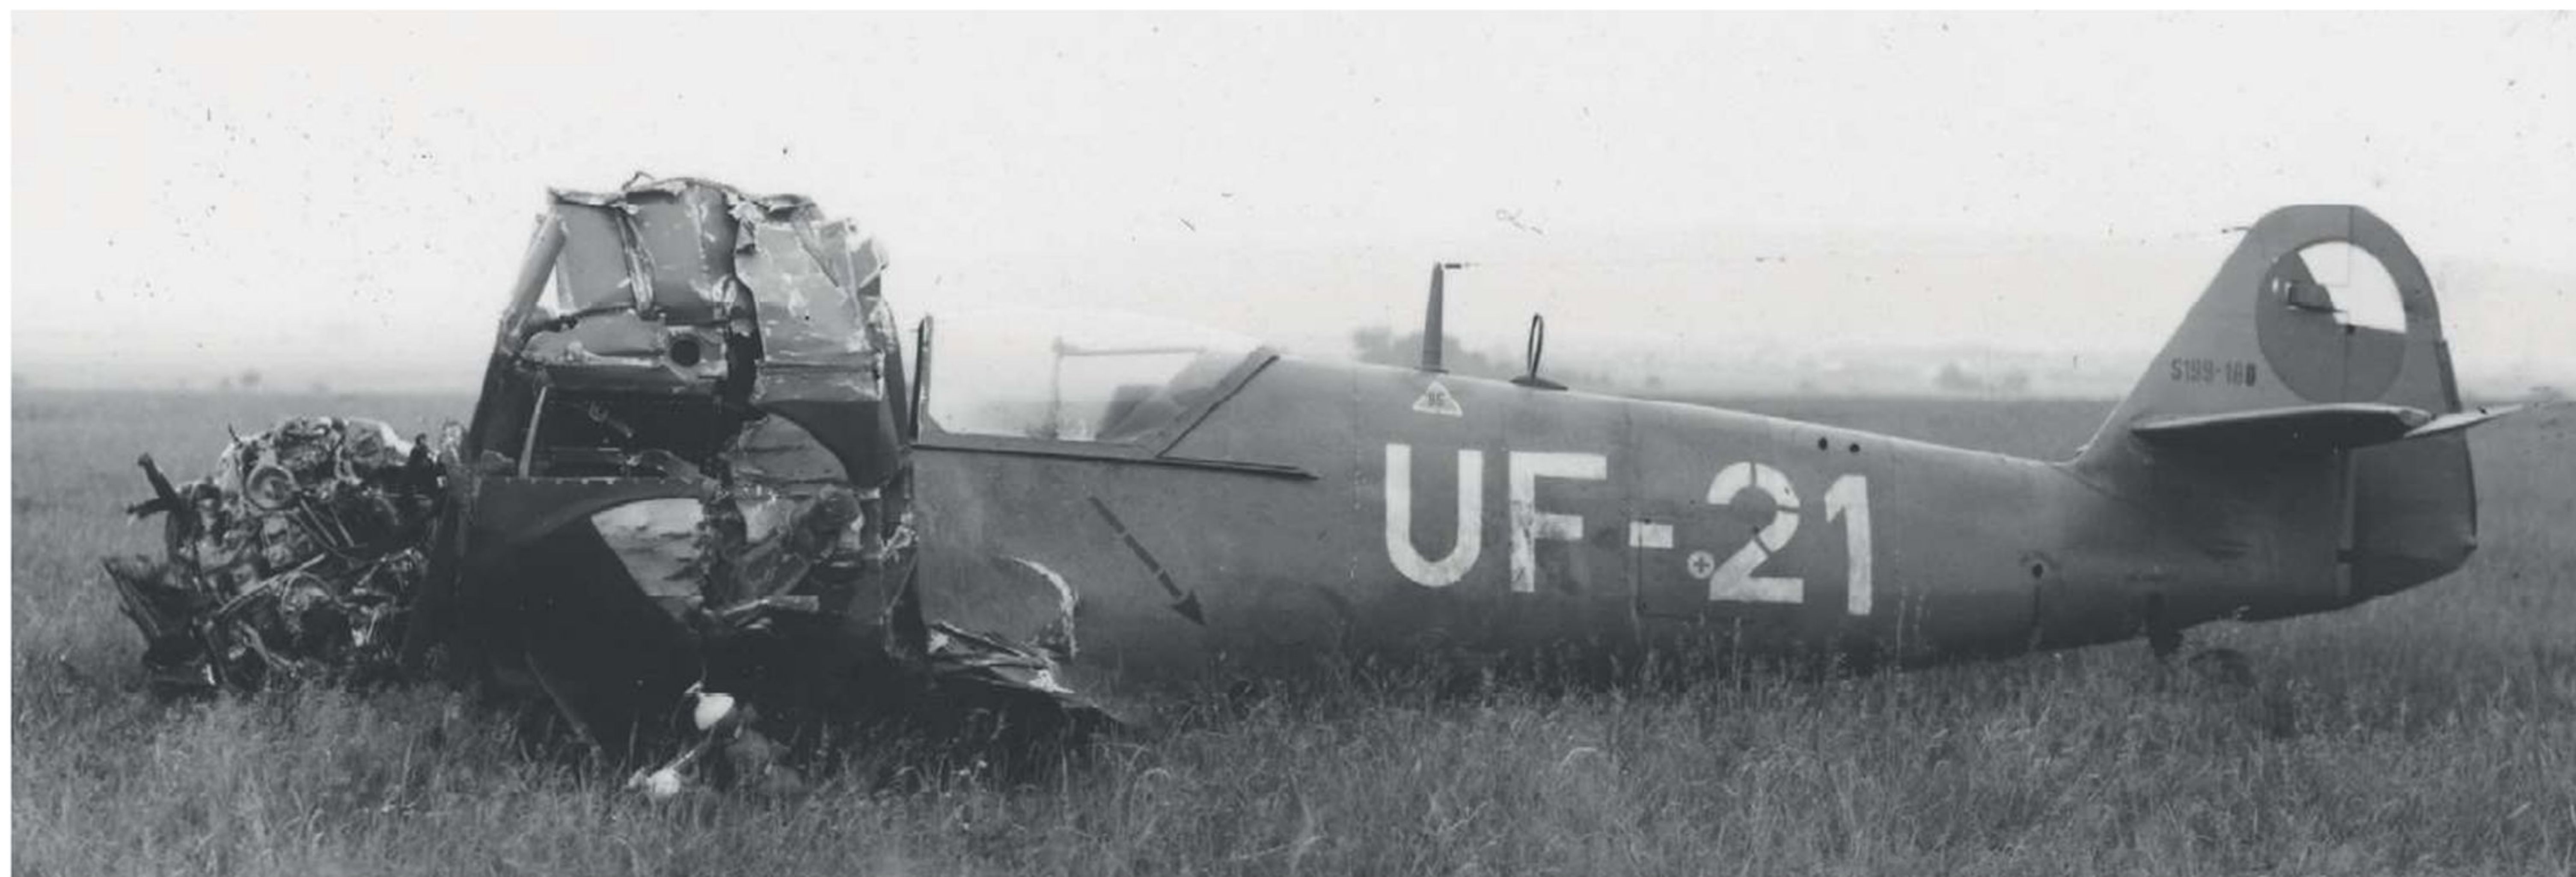
An example of the dark green painted aircraft (S-199.180) featuring the white UF-21 fuselage codes and non-standard blue outline of the national insignias. This aircraft was written off after the crash of pilot student Bohuslav Solta from the 4th Aviation School in Prostějov-Stichovice on May 30, 1953.

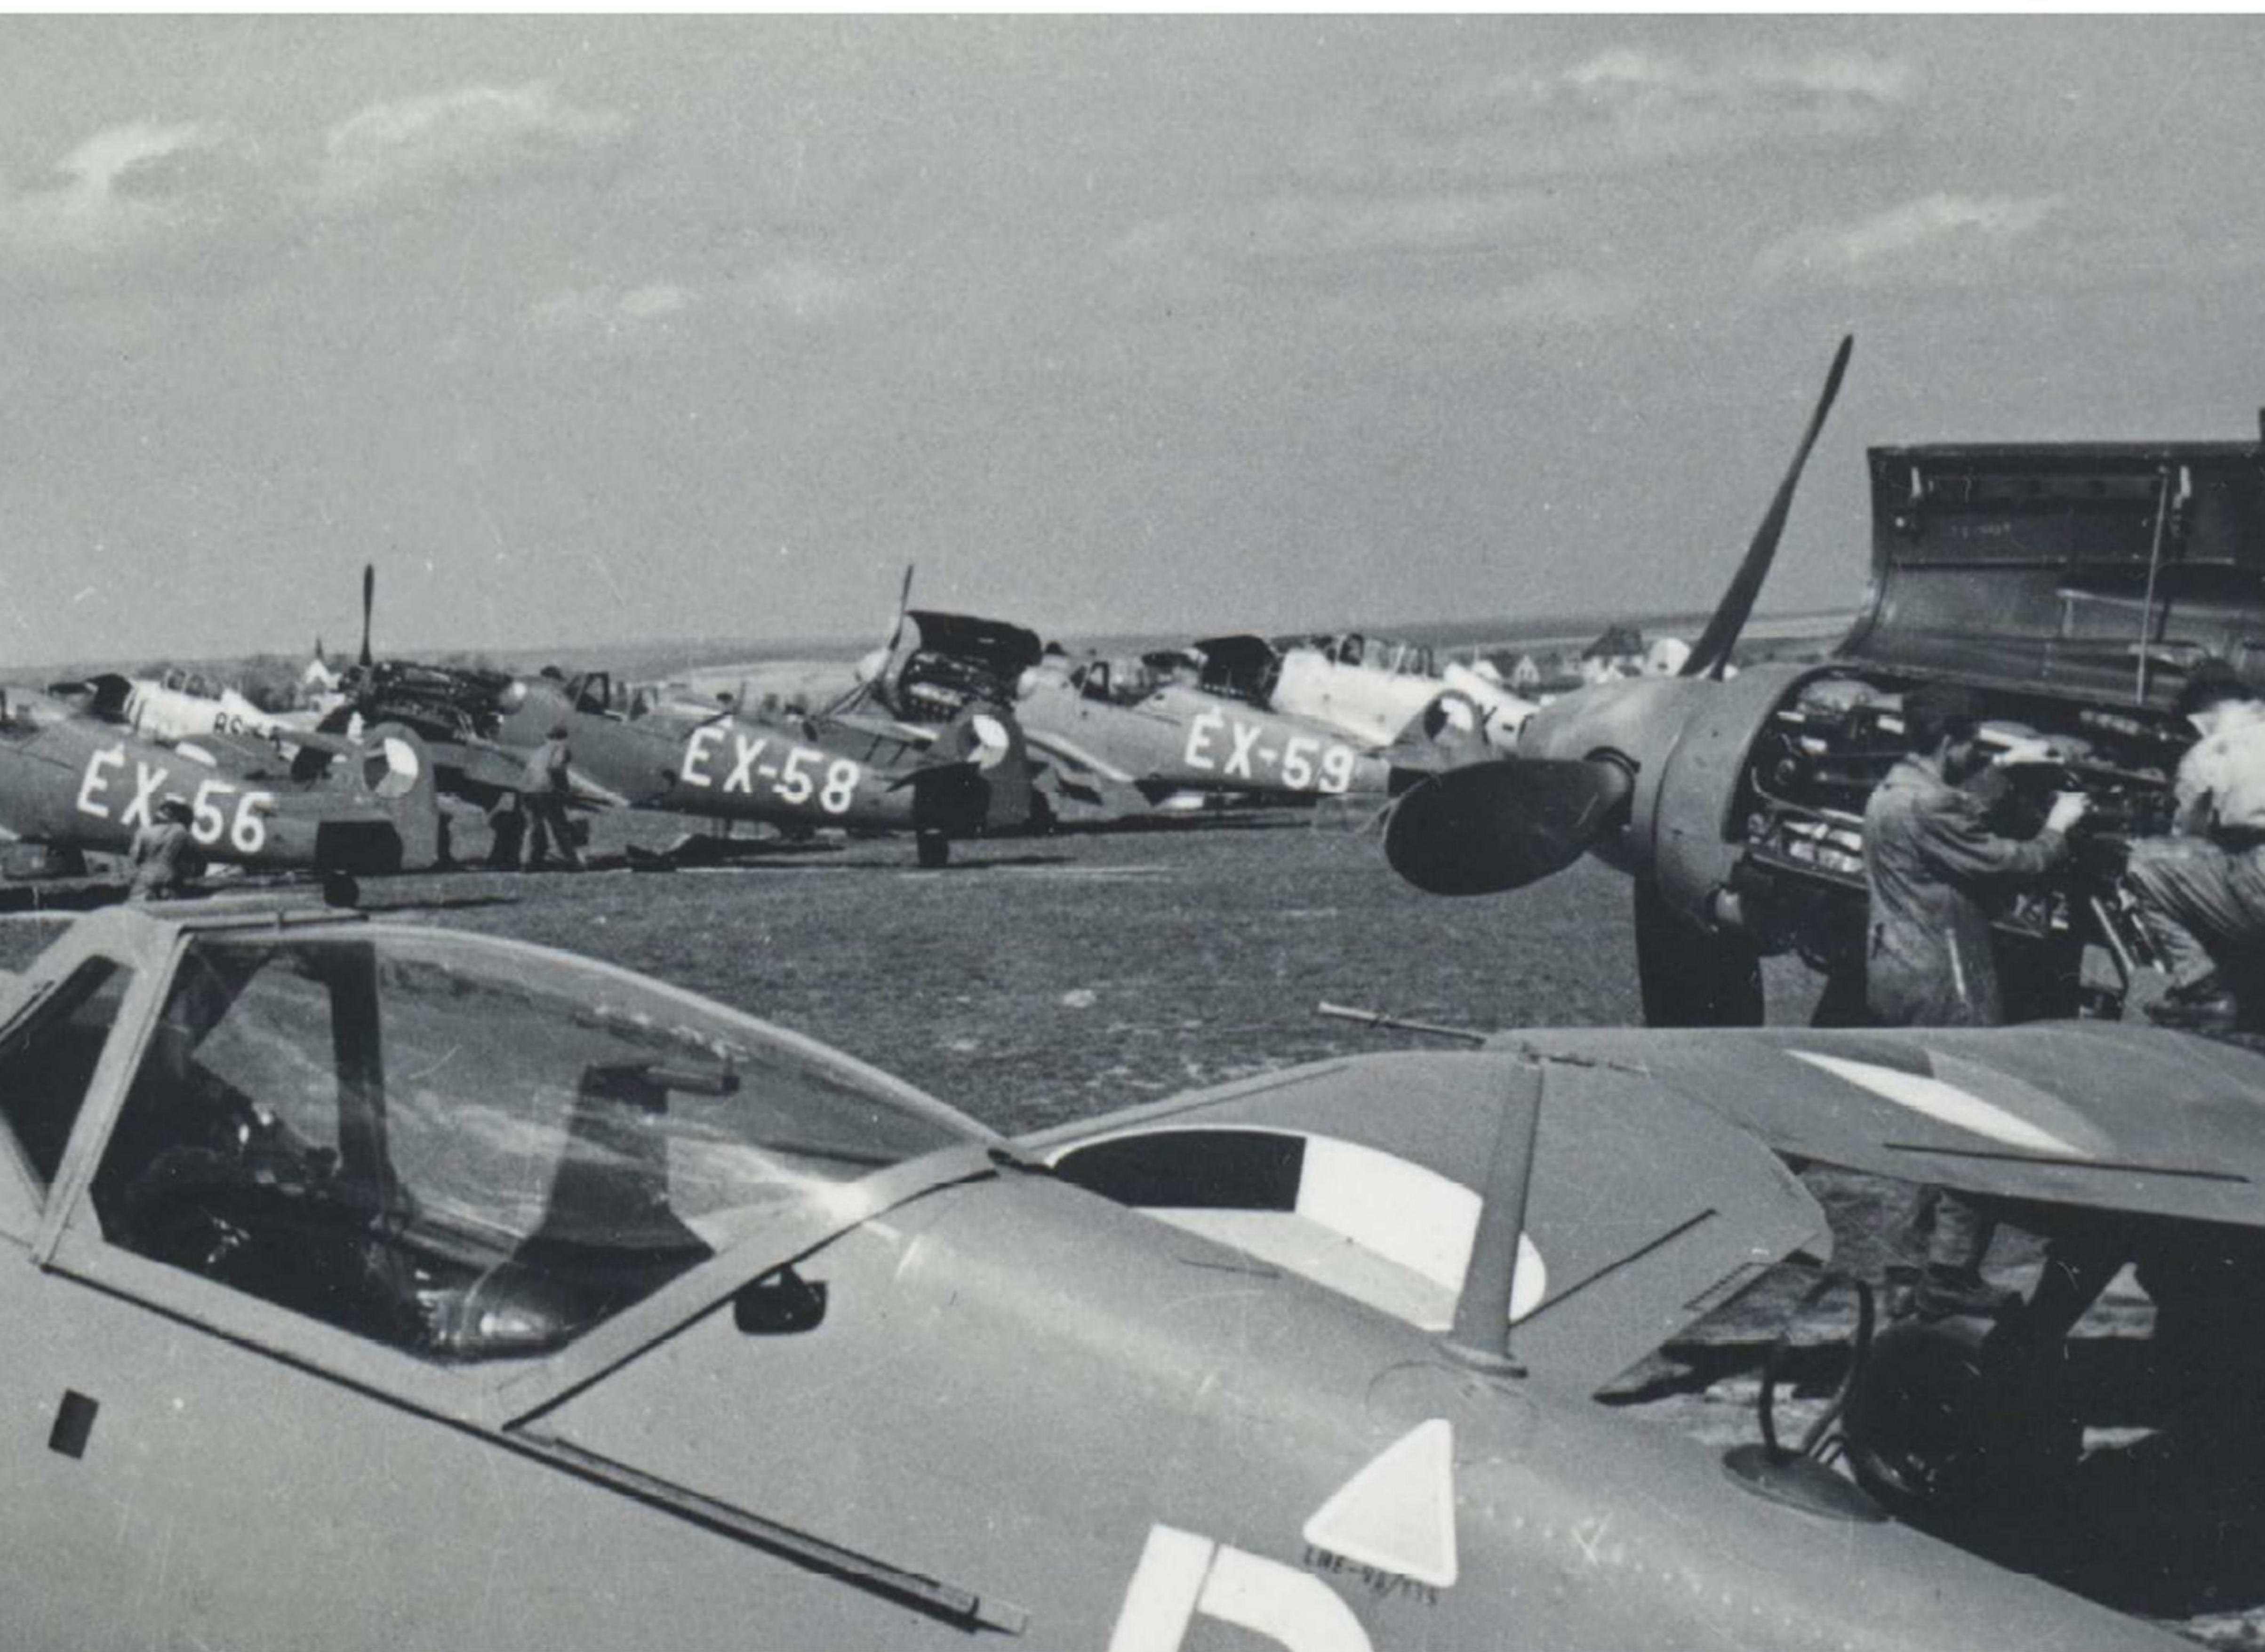
Crop of the well-known photograph of the apron with S-199 and C-2 aircraft from the 18th Fighter Squadron in Pardubice, spring 1954. The dark painted aircraft in the middle is EX-58 belonging to the 3rd section of the 3rd flight (initially this was a photo reconnaissance aircraft). In this photograph we can compare the light gray-green finish of the older aircraft with the newer (or overhauled) aircraft sprayed with dark green color. In both cases the fuselage codes are white and the national insignia feature a blue outline.

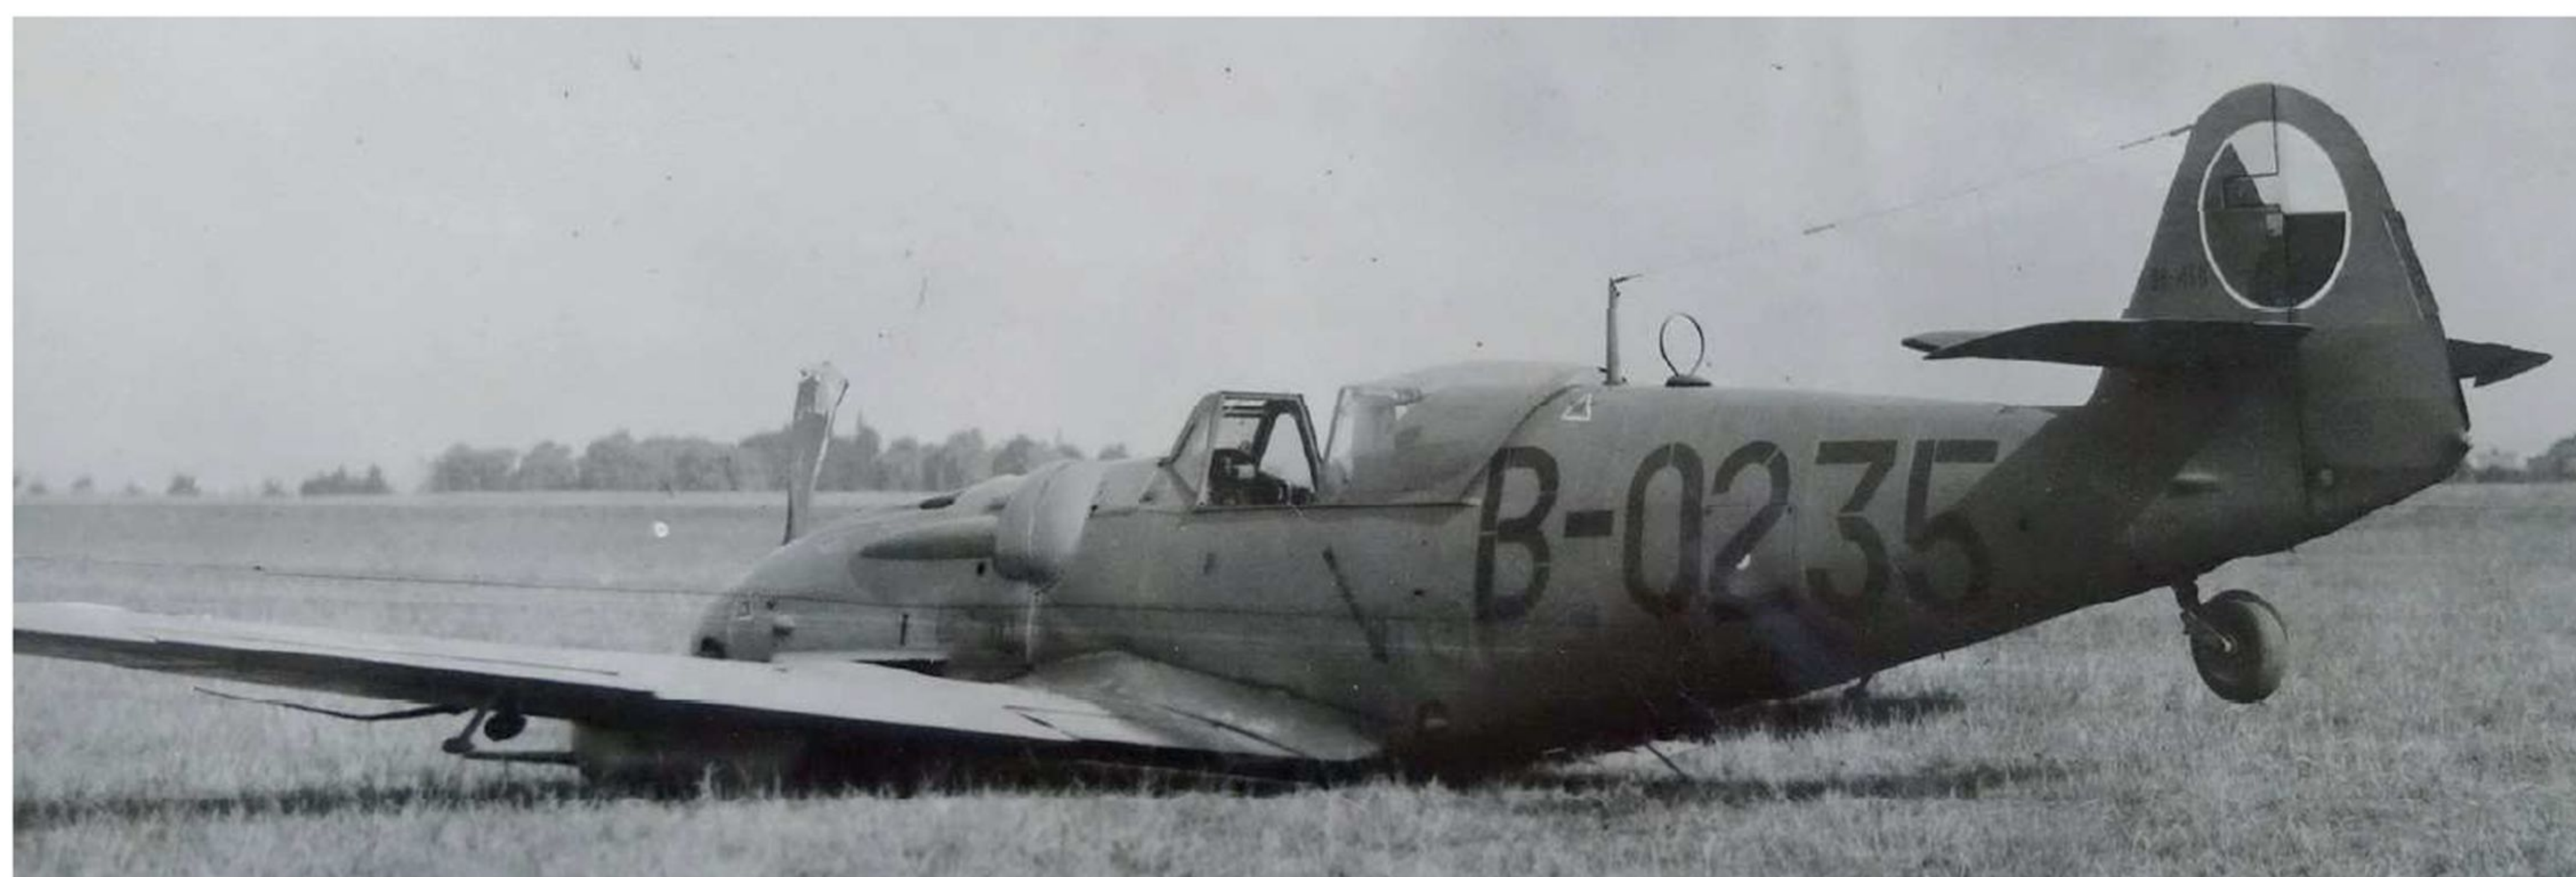
S-199.458 (manufactured by Aero) flown by Lt. Zdeněk Štefl grounded after the mid-air collision with another „onehundredninetynine“ in the area of Letkov village on July 15, 1952. The aircraft belonged to the 2nd Flight of the 51st Fighter Squadron in Pilsen. The code B-0235 indicates the previous owner, the National Security Aviation (disbanded on December 23, 1950). The Czechoslovak insignia with the standard 15mm white outline are painted in accordance with the 2nd Order of the National Markings Application dated October 1947.

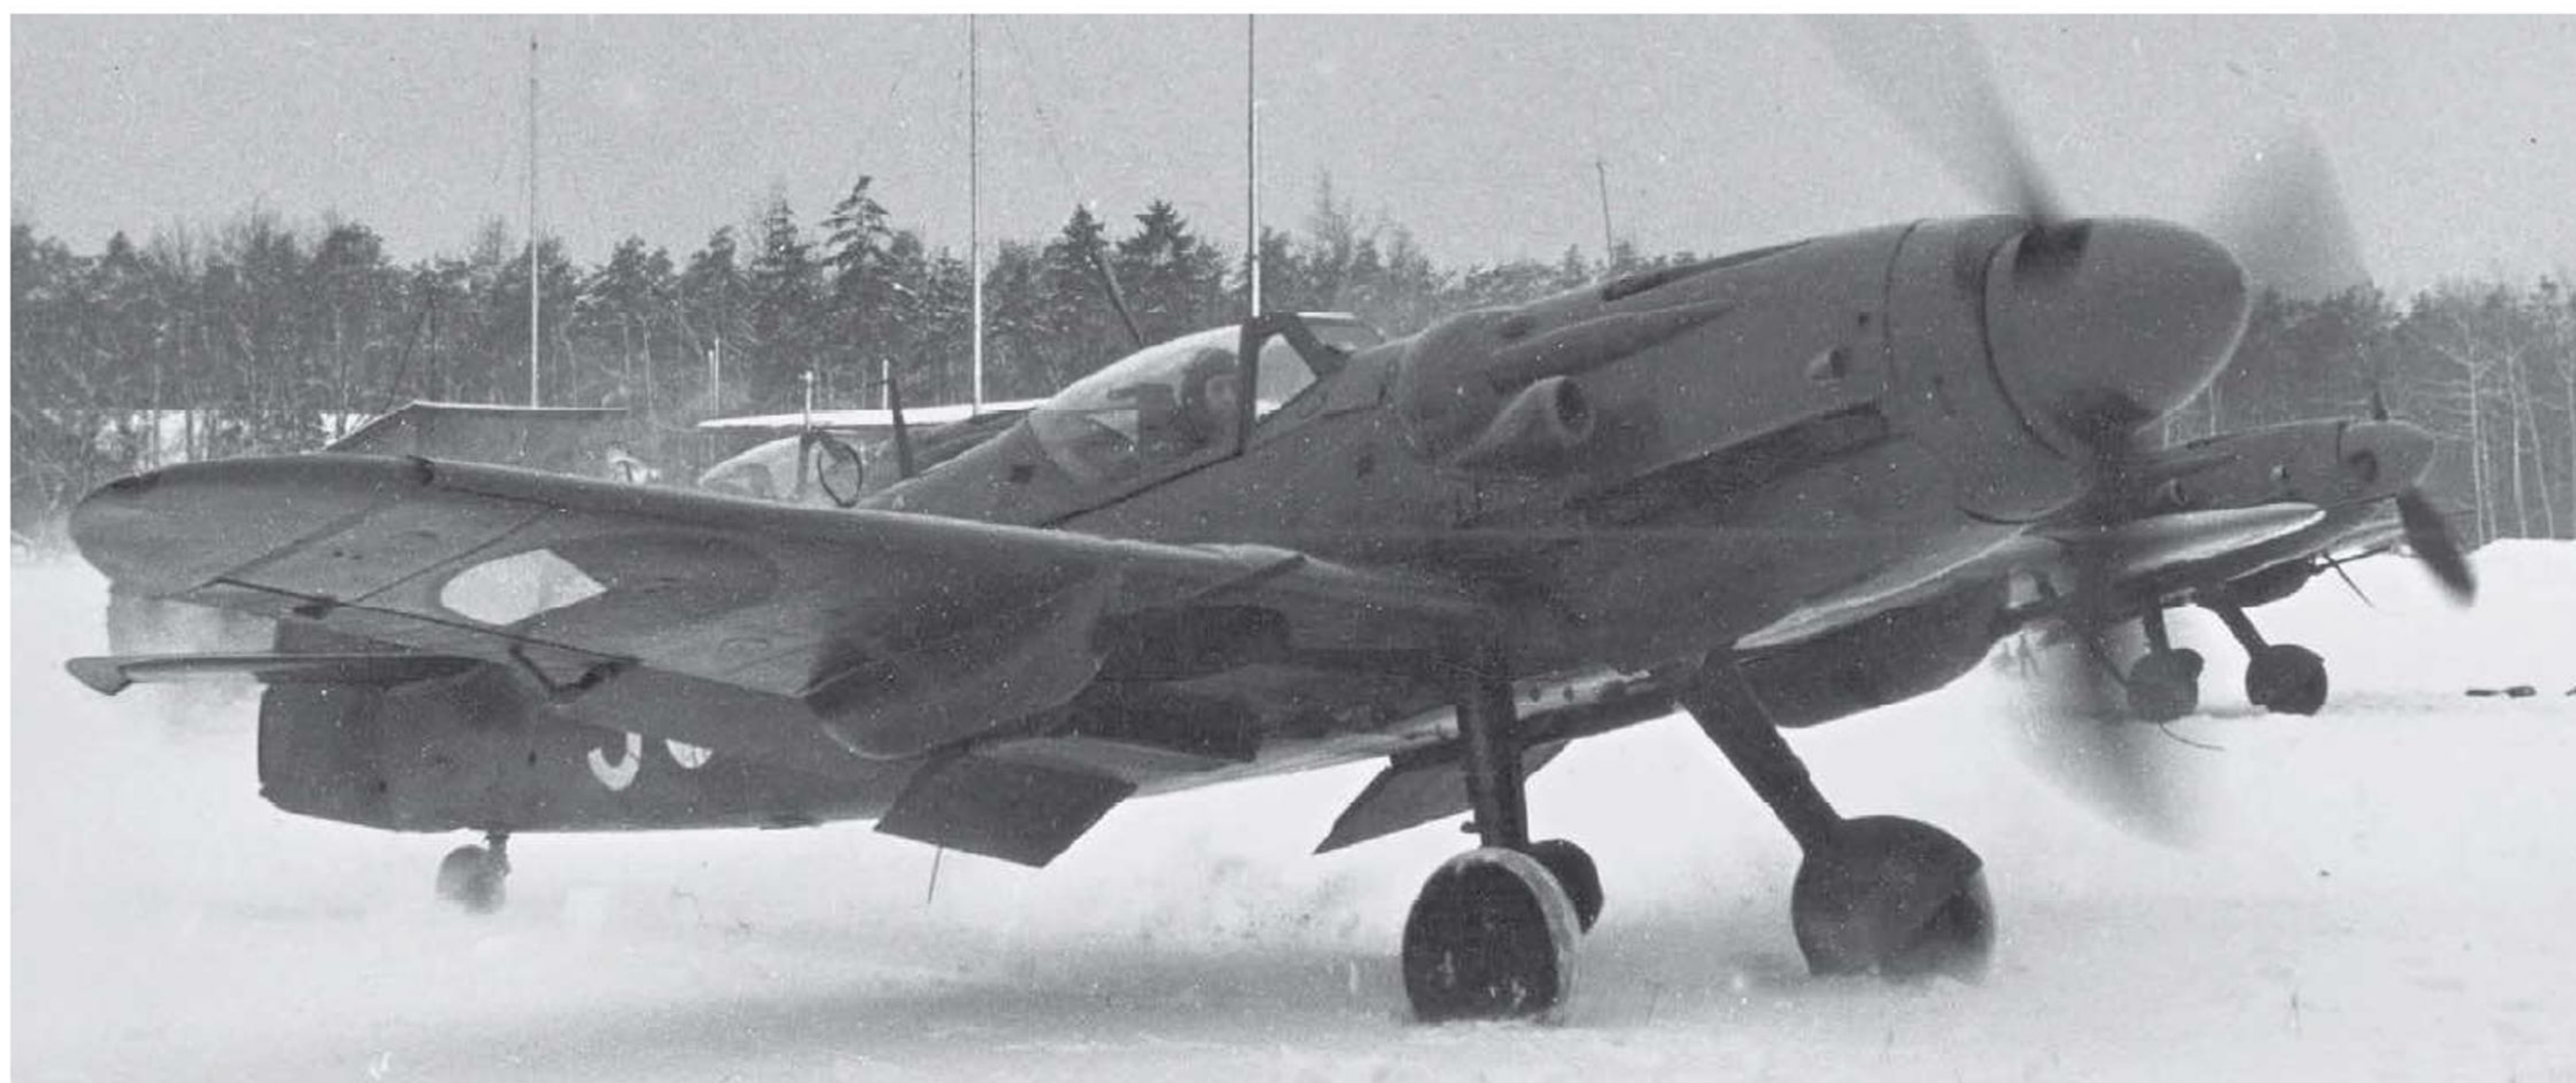
Image of the Skoda-Kauba SK 257 wing fragment from VHU collection: light gray-green paint applied on the aileron fabric covering that may have influenced the Czechoslovak aviation industry after the war. We cannot exclude this paint (of which some stocks could have remained) and its shade as potential application on the Czechoslovak airplanes, including S-199.

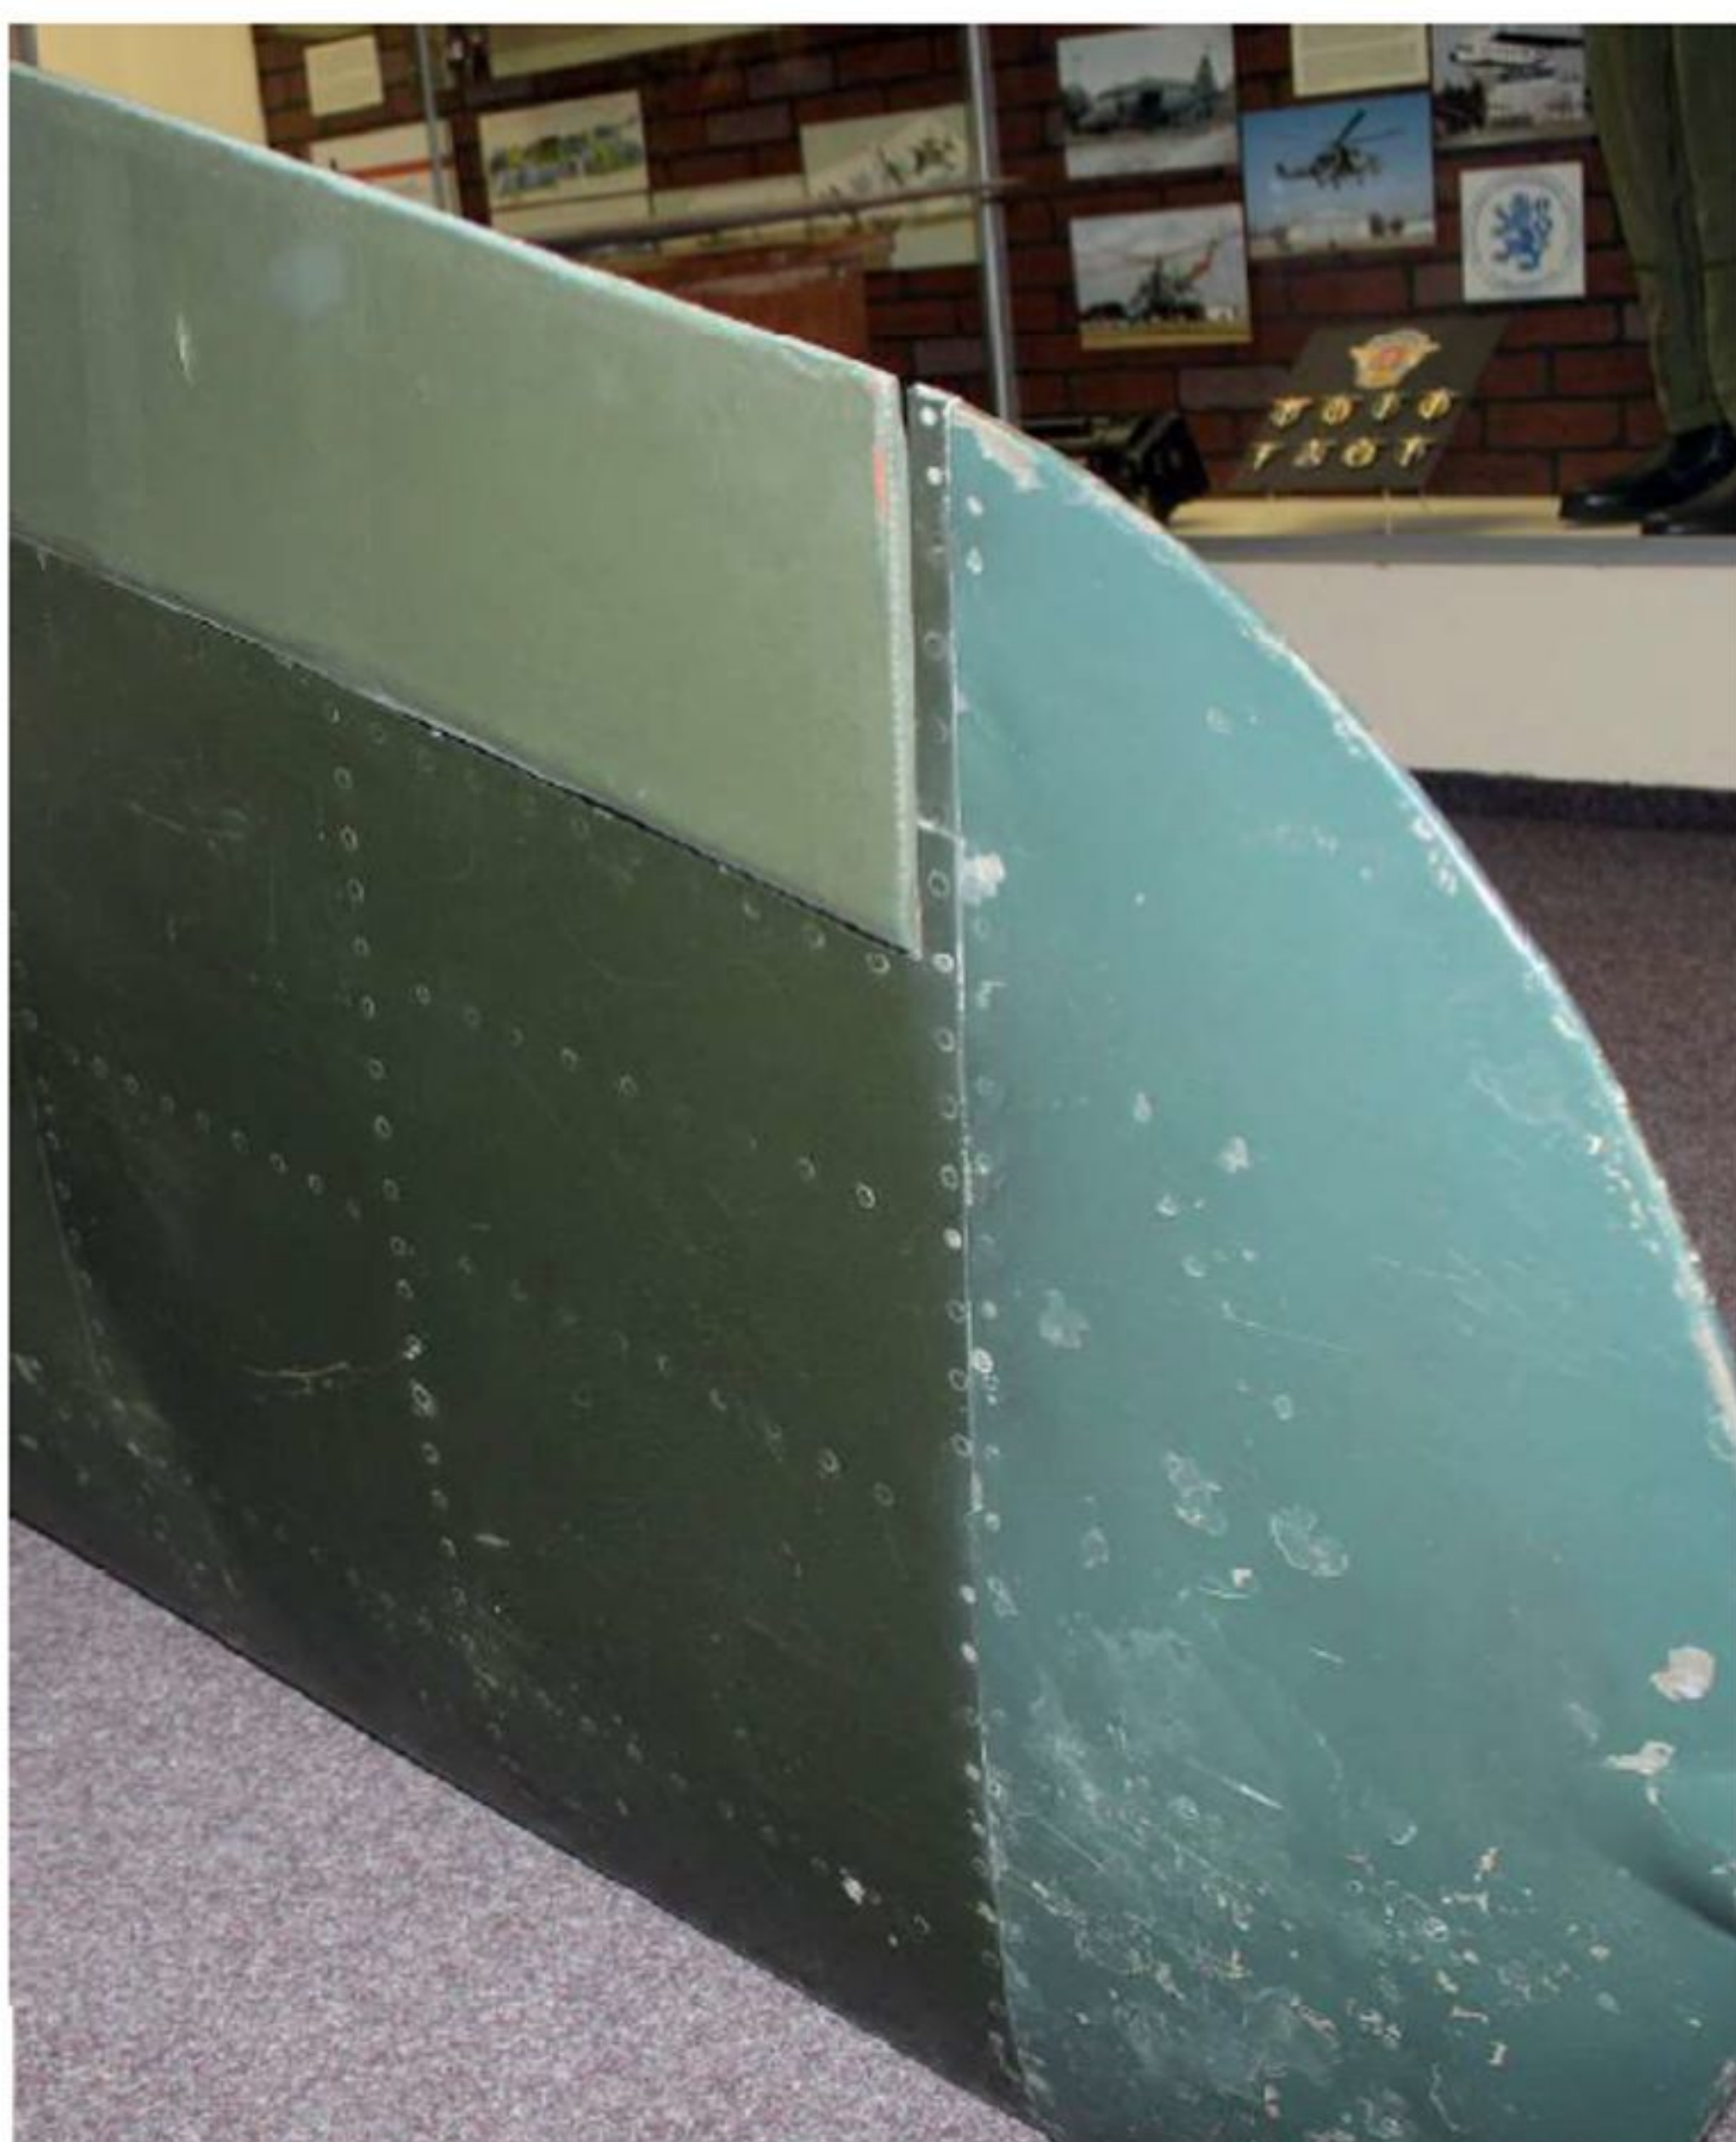
The fragment of the original Avia drawings nr.MeS 101 dated January 1946 which prescribed the location and dimensions of the wing circular national markings. It was specific for S-99 aircraft but later applicable to S-199 as well.

including 10 mm thick outline (i.e., the actual insignia diameter was 880 mm), insignia distance from the edge of the wingtip was 1500 mm, insignia center was 615 mm from the wing's leading edge on the upper surfaces and 550 mm on the lower surfaces. The insignia on the vertical tail surface was to have 550 mm diameter including 10 mm thick outline (i.e. the insignia's actual diameter was 530 mm). The majority of S-199s were marked according to the aforementioned orders as far as the white outline is concerned ("a stripe" in the period terminology) however, as always the exceptions existed and therefore the photographs document both light and dark painted aircraft sporting blue outlined national insignia. It could have been a result of the older order from 1946 as well as frequently applied rule of thumb „dark outline (i.e., blue) on the light basis.
